**ENHANCING THE CORROSION RESISTANCE OF API 5L X70 PIPELINE STEEL
THROUGH THERMOMECHANICALLY CONTROLLED PROCESSING**

A Thesis Submitted to the
College of Graduate and Postdoctoral Studies
In Partial Fulfillment of the Requirements
For the Degree of Doctor of Philosophy
In the Department of Mechanical Engineering
University of Saskatchewan
Saskatoon

Enyinnaya George Ohaeri

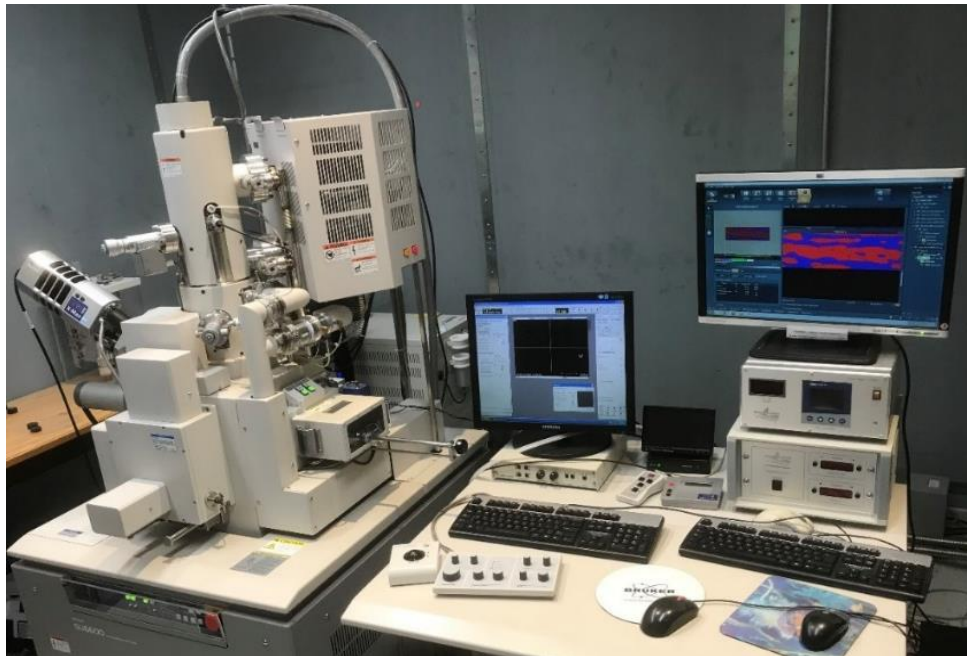
Fig. 3.5 Photograph of the field emission Hitachi SU6600 SEM/EBSD device connected to a computer running AZTEC 2.0 software

Pipeline steel specimens used for EBSD analysis were vibratory polished in a 0.04 μm silica solution for another 12 h after mechanical polishing. The Field Emission Hitachi SU6600 Scanning Electron Microscope pictured in Fig. 3.5 was used for this investigation under ultra-high vacuum conditions. All EBSD scans were taken with an accelerating voltage of 30 kV, a tilt angle of 70°, and a working distance of approximately 17 mm was maintained. Tilting the specimen ensures that more diffracted electrons are collected by the detector. Electron diffraction patterns were acquired on Oxford Instrument's AZTEC 2.0 software suite using a step size of 0.14 μm and a binning mode of 8 x 8 pixels. Post-processing was carried out on the raw data with the Oxford Instrument's Channel 5 software. The average size of grains in each specimen was determined as an estimate of the average diameter of all grains present within the scan area. Grain boundary distribution with a misorientation angle (θ) within the range of $5^\circ < \theta < 15^\circ$ was regarded as low angle grain boundary (LAGB), while $15^\circ < \theta < 62.5^\circ$ was a high angle grain boundary (HAGB). For recrystallization fraction studies, sub-grains are separated by misorientation angles (θ) ranging from $1^\circ < \theta < 7.5^\circ$ and grains are separated by $\theta > 7.5^\circ$. Meanwhile, the kernel average misorientation (KAM) measurements covered a range of $\theta < 5^\circ$. Then, coincident site lattice (CSL) grain boundaries were categorized within $3 \leq \Sigma \leq 33$ at a deviation of 15° according to the following expression: $\Delta\theta_{max} = 15^\circ / \sqrt{\Sigma}$ (Brandon criterion) [273]. The same microstructural characterization technique was repeated after testing each pipeline steel specimen for hydrogen induced cracking susceptibility.

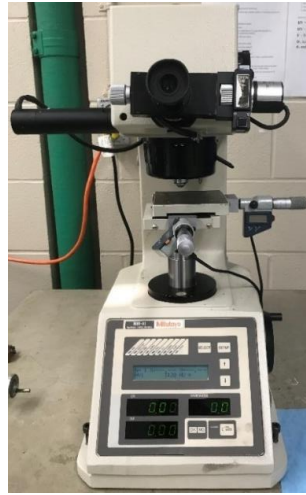
Fig. 3.6 Photograph of the MVK-H1 Mitutoyo Vickers micro-hardness tester used for this study

The micro-hardness of the test specimens was determined via indentations with the aid of an MVK-H1 Mitutoyo hardness tester shown in Fig. 3.6. The machine was set to a fixed load of 1 kg before taking measurements. During each test, the indenter contacts the specimen for about 10 sec. Thereafter, readings were taken based on the dimension of the indent. Up to ten different measurements were taken prior to reporting the average values in Vickers scale (HV).

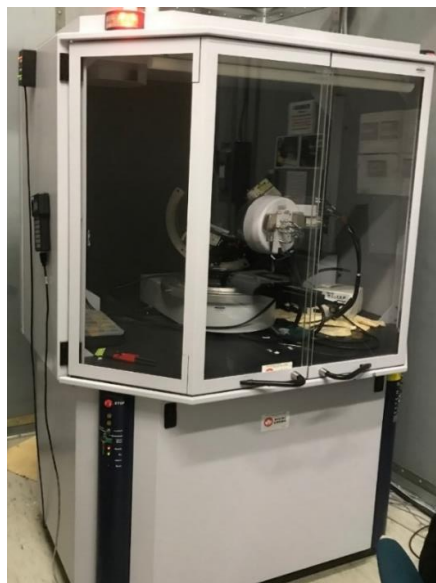
Fig. 3.7 Photograph of the Brunker D8 X-ray diffractometer used for this study

The Brunker D8 diffractometer with a Cr K α radiation source which was used for the texture measurements is pictured in Fig. 3.7. Incomplete pole figures for (110) and (200) planes were first plotted from raw XRD data. Then, orientation distribution functions (ODF) were constructed from the incomplete pole figures with the help of Resmat – TexTools software.
